# Manhole Inspection Summary

Manhole # S37MM\_026MH

Insp Date: 1/31/07 1:04 PM

**Location** Address: **415 21ST ST**

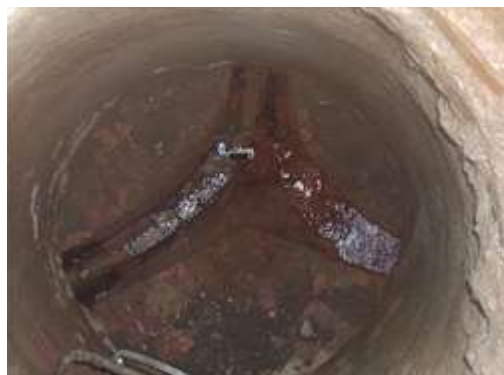
Top View

Infiltration: ☐ None ☒ **Joint** ☐ Cracks ☐ Mortar ☐ Roots ☒ **Wall**

Infiltration: ☐ None ☐ Joint ☐ Cracks ☐ Mortar ☐ Roots ☒ **Wall**

**Surcharge** ☒ **Evidence Of Surcharge** Depth: **1.5** (ft.) ☐ Active Surcharge Present

Adjustment and Barrel infiltration.  
Evidence of surcharge - Bench debris.  
Channel debris.

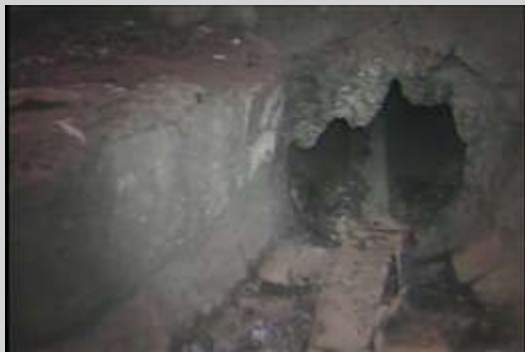
### 8 in. Circular Gravity Sewer Pipe Out @ 12 O'Clock

Invert Depth: **8.90** (ft.) Flow Characteristics: **Slow**

Infiltration: **Evidence** Pipe Seal Cond: **Unknown**

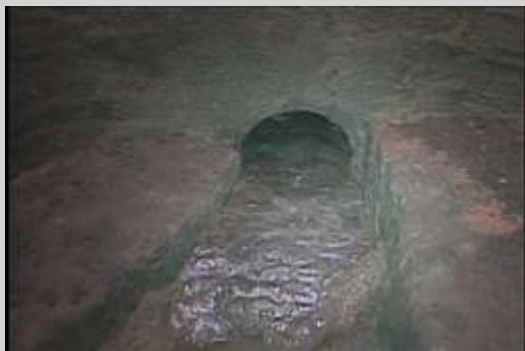
### 6 in. Circular Gravity Sewer Pipe In @ 3 O'Clock

Deposits: ☐ None ☒ **Mud** ☐ Sludge ☒ **Debris** ☐ Grease

Silt Depth: **2** (in.) Deposits Extent: **Medium**

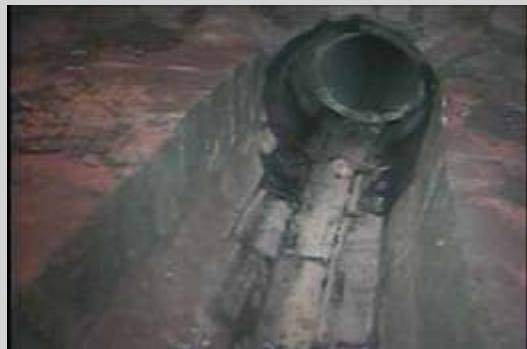
Pipe In @ 8 O'Clock

Infiltration: **Evidence**
